The following describes how to deal with the situation where the system that senses the position of the convertible top latch is intermittently or always indicating that the convertible top is unlatched. This results in the windows always remaining the withdrawn (about an 1" open) position and the instrument cluster light flashing while driving. The fix for this is to bend the actuator arm so that proper operation of the microswitch is assured. The following photos provide the details.

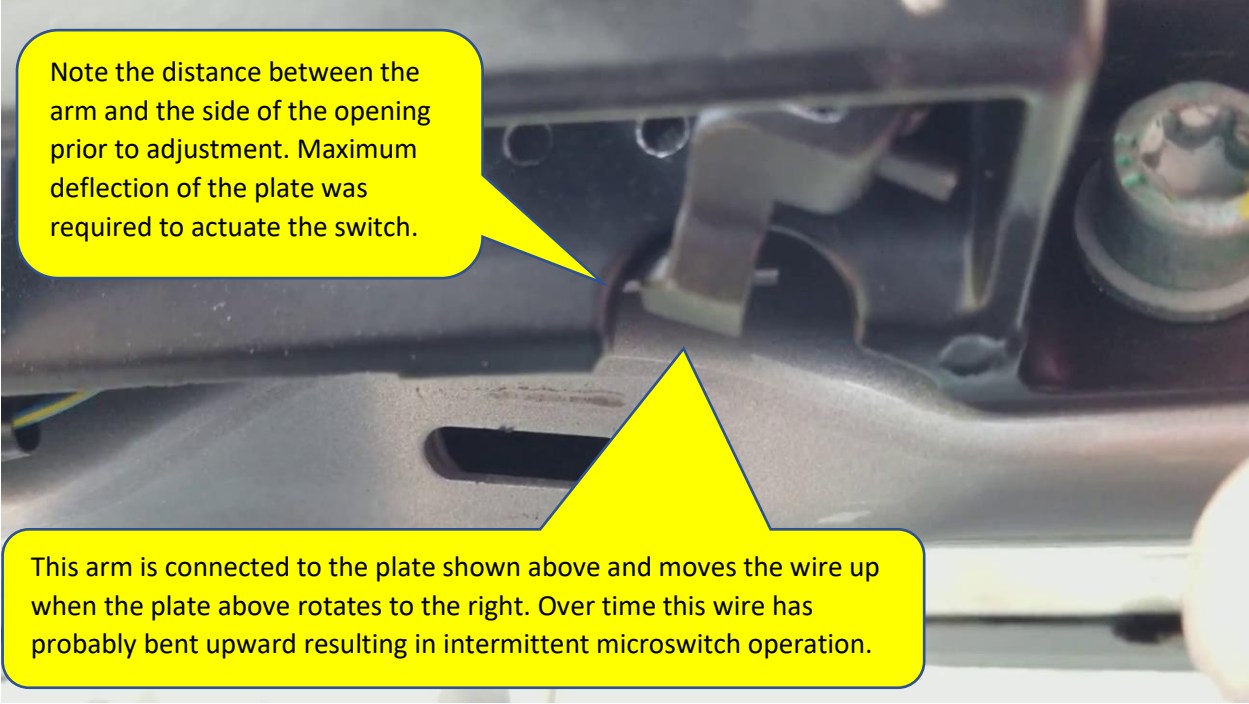
This arm is connected to the plate shown above and moves the wire up when the plate above rotates to the right. Over time this wire has probably bent upward resulting in intermittent microswitch operation.

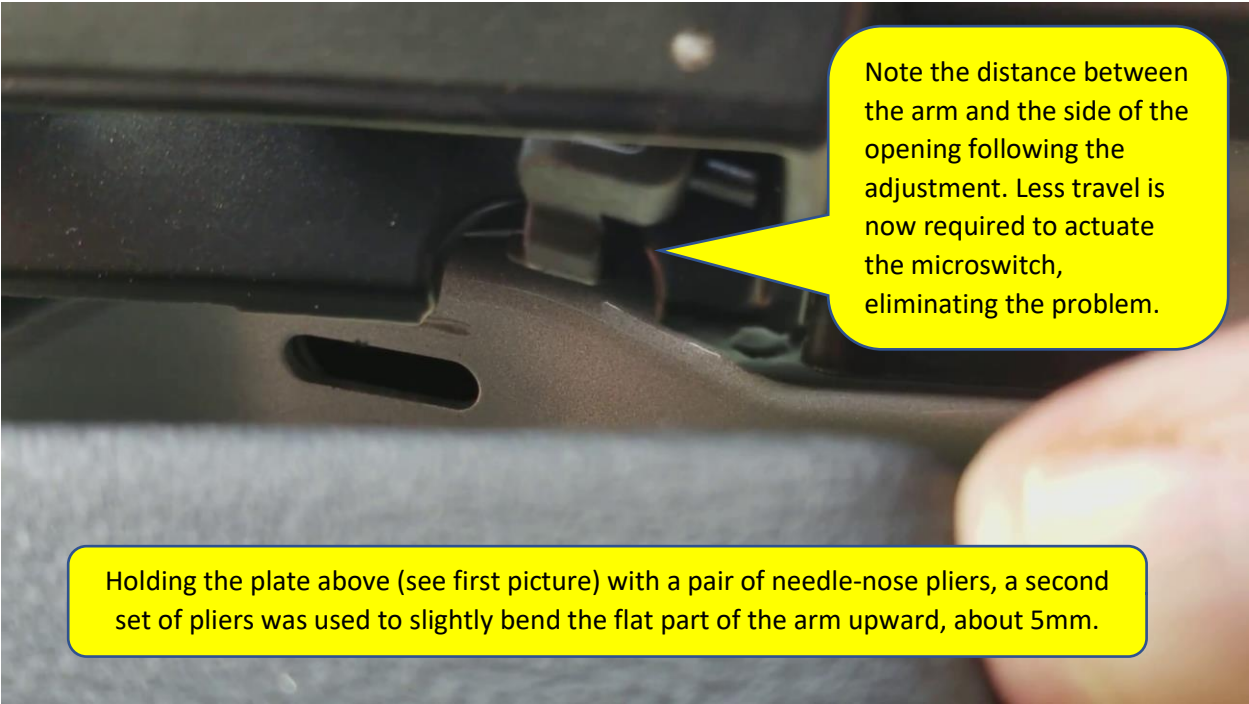
Note the distance between the arm and the side of the opening following the adjustment. Less travel is now required to actuate the microswitch, eliminating the problem.

Holding the plate above (see first picture) with a pair of needle-nose pliers, a second set of pliers was used to slightly bend the flat part of the arm upward, about 5mm.
